# Manhole Inspection Summary

Manhole # S57A\_\_012MH

Insp Date: **6/25/08 10:19 AM**

**Location** Address: **201 n haven st**

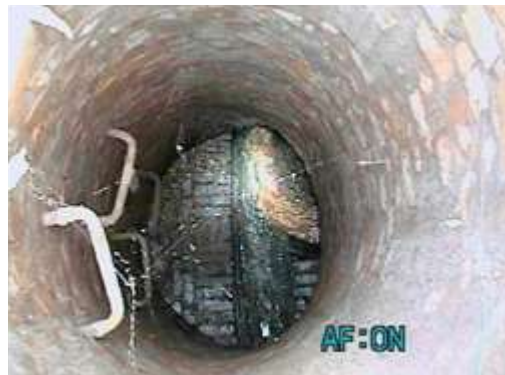
Top View

Condition: **Cracked**

Condition: ☐ Sound ☒ **Cracked** ☐ Root Intrusion ☒ **Loose Brick** ☐ Deteriorated

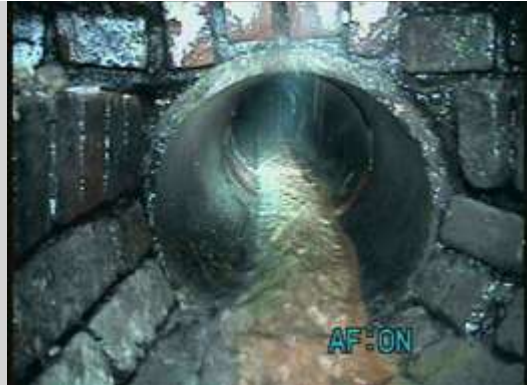
12 O'Clock Outflow

12 in. Circular Gravity Sewer  
Pipe Out @ 12 O'Clock

Pipe Material: **Clay** ☐ Pipe Lined

Invert Depth: **12.15** (ft.) Flow Characteristics: **Fast**

Infiltration: **None** Pipe Seal Cond: **Unknown**

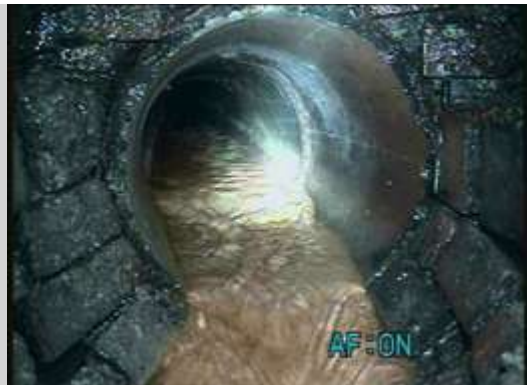
3 O'Clock Inflow

12 in. Circular Gravity Sewer  
Pipe In @ 3 O'Clock

Pipe Material: **Clay** ☐ Pipe Lined

Invert Depth: **12.06** (ft.) Flow Characteristics: **Fast**

Infiltration: **None** Pipe Seal Cond: **Unknown**

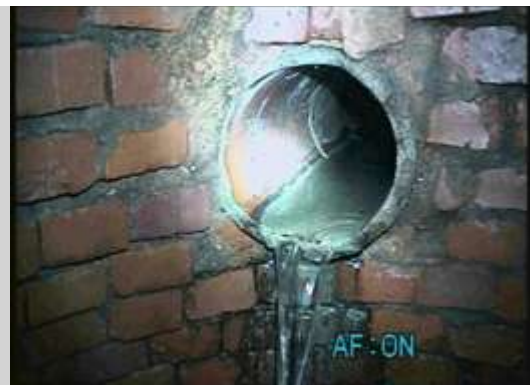
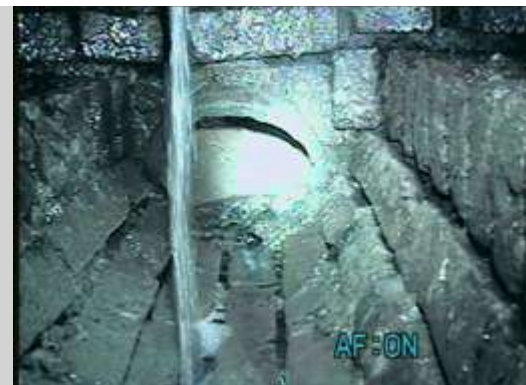
6 O'Clock Inflow

8 in. Circular Gravity Sewer

Pipe In @ 6 OClock

Drop In @ 6 OClock

Pipe Material: **Clay** ☐ Pipe Lined

Infiltration: **None** Pipe Seal Cond: **Unknown**

Drop Condition: **Open**
